**EVALUATION OF RAIN-EROSION-RESISTANT MATERIALS  
TO PROTECT THE HH-43B/F HELICOPTER ROTOR**

TECHNICAL REPORT SEG-TR-65-53

AUGUST 1966

SYSTEMS ENGINEERING GROUP  
RESEARCH AND TECHNOLOGY DIVISION  
AIR FORCE SYSTEMS COMMAND  
WRIGHT-PATTERSON AIR FORCE BASE, OHIO

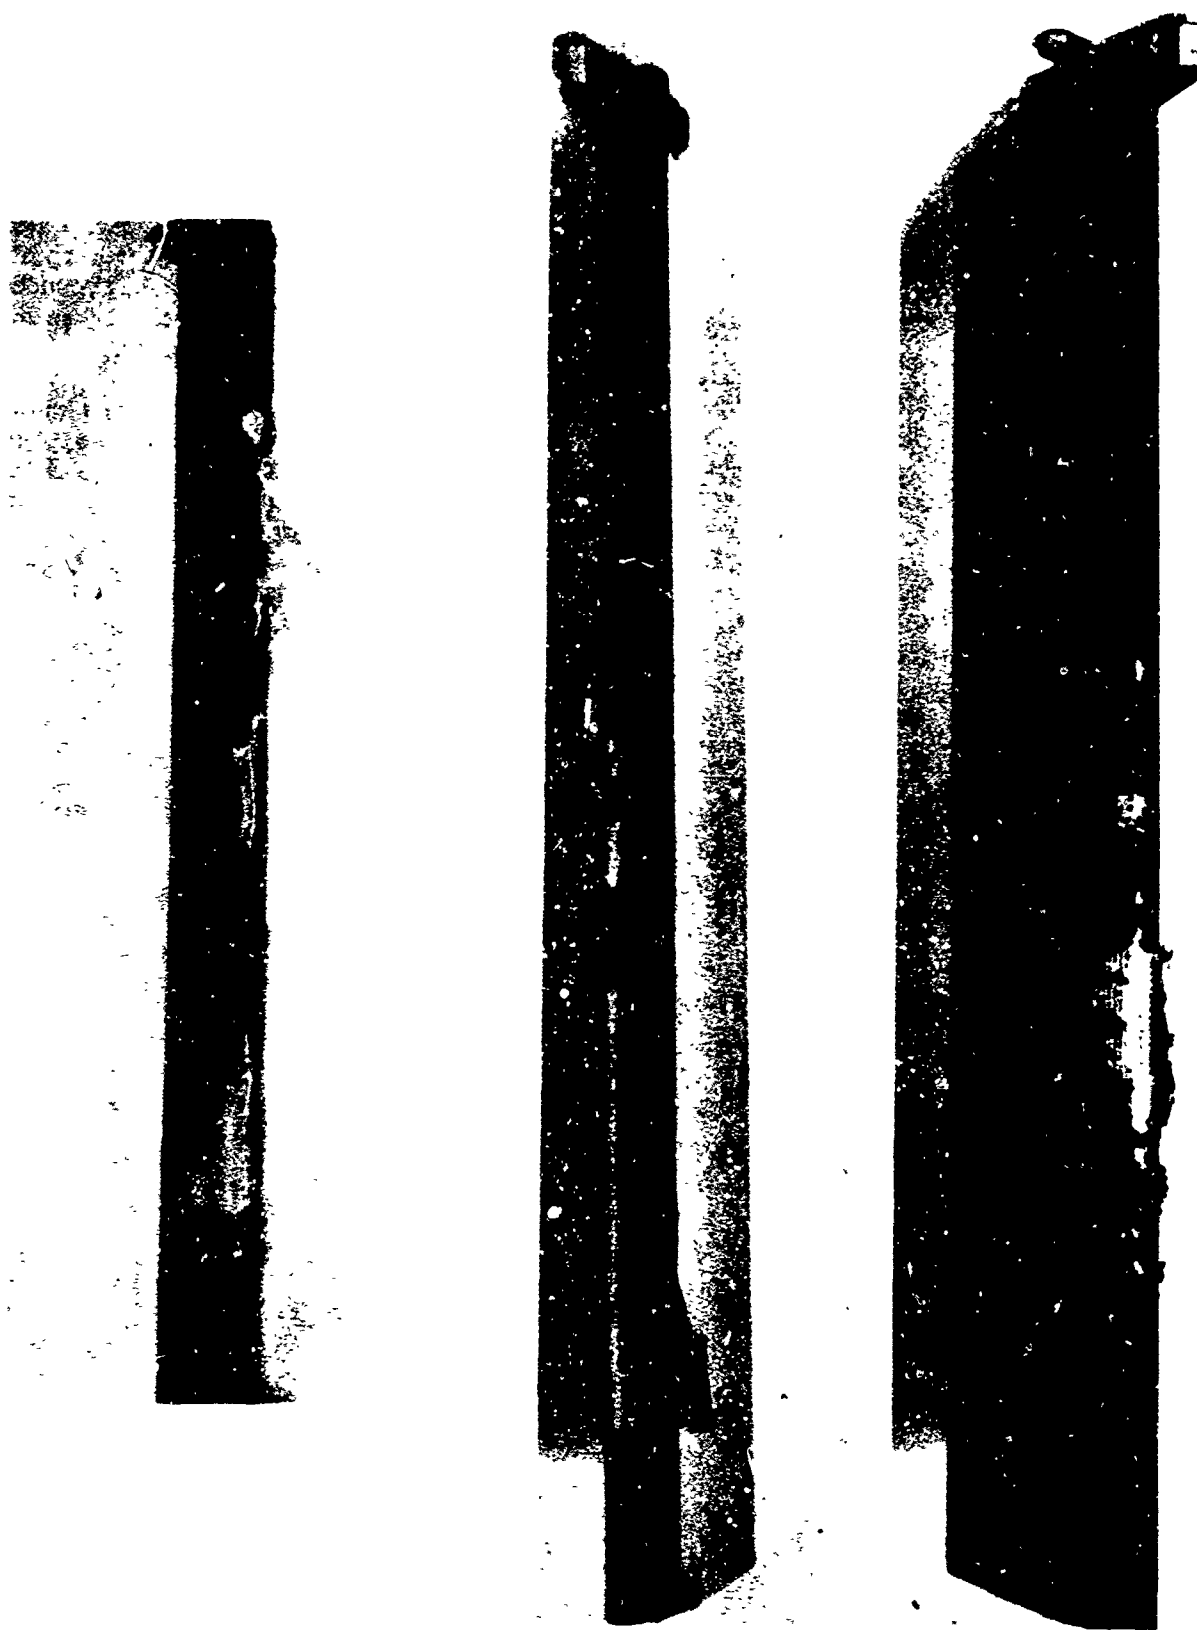
The servo flap of the production models of these helicopters is constructed of high-quality spruce and maple wood, birch plywood, and nylon rip-stop cloth, and the leading edge is sprayed with a layer of neoprene rubber over the rip-stop cloth. The primary objective of this test program was to determine a suitable material for protecting the HH-43 B/F helicopter servo-flap leading edge from rain erosion when operating in a rain environment. Typical damage to the servo flaps when operating in rain is illustrated in Figure 2.

Figure 2. Typical In-Flight Servo Flap Damage From Operation in Rain

A comparison of Figures 2 and 16 shows the similarity and degree of duplication of the test sample failures to actual service encountered failures of the -115 material.

The mode of failure for both was for water to enter initially formed pin holes in the material and then for the material to separate and peel from the nylon rip-stop-cloth.

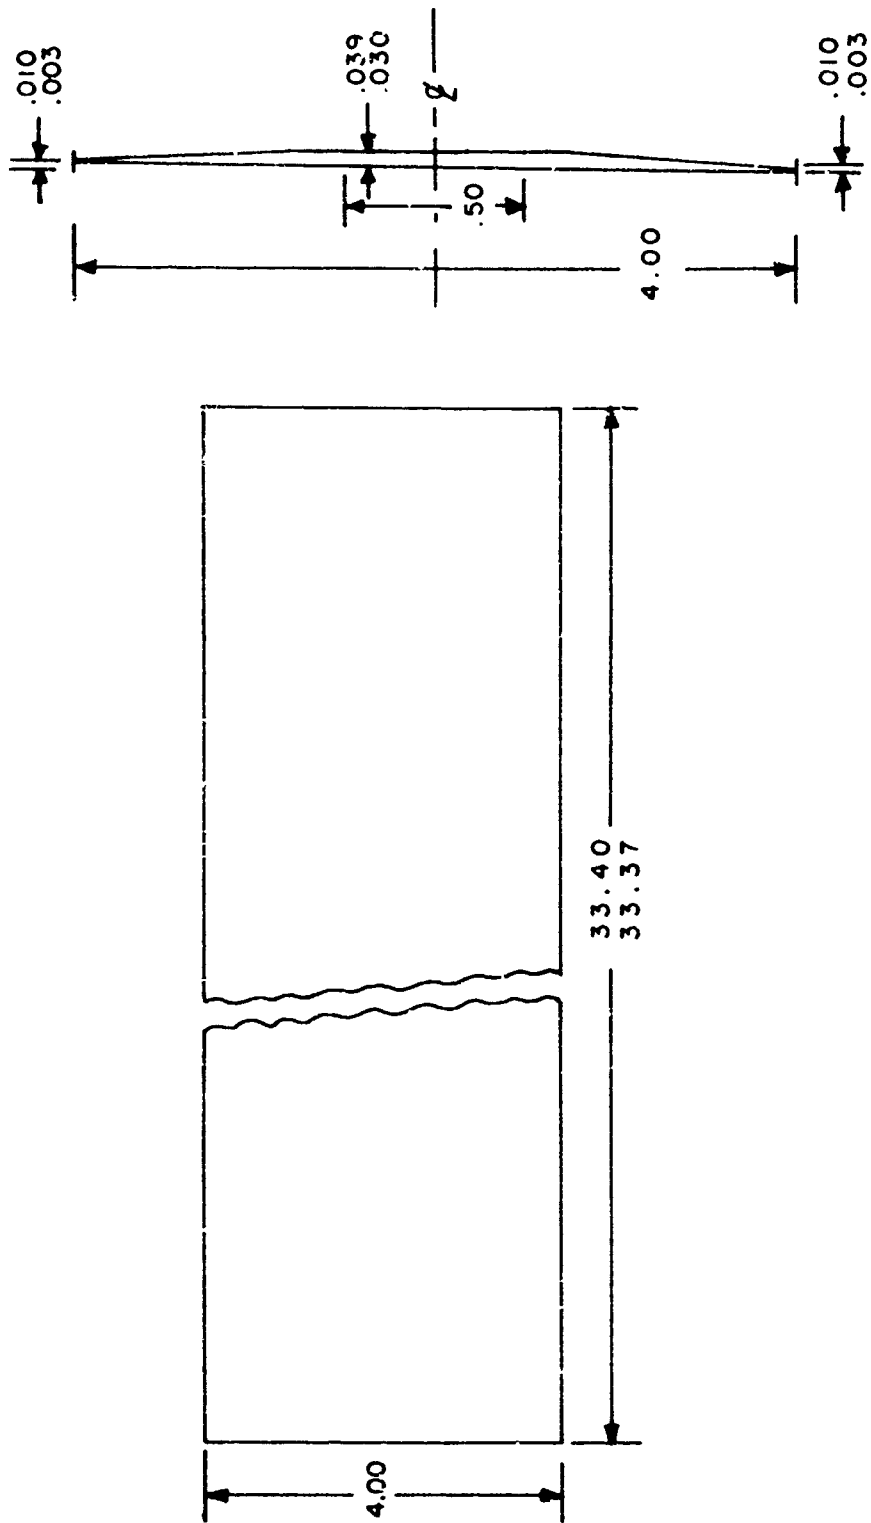
Figure 24. Detail Diagram of Recommended Protective Strip of -143T Material

As a result of the comparison tests of the -131T and -143T polyurethane, protective strips of -143T material shaped as shown in Figure 24 were recommended for installation on the leading edges of all HH-43B/F helicopter servo flaps.

b. Due to the little degradation in resistance caused by carbon impregnation and the unknown effect of ultraviolet radiation (sun light), the Sample -143T material tapered from leading to trailing edge was recommended.
